Ekar sprocket cassette spacer update

We are writing to you about the Ekar groupset and its sprocket cassette.

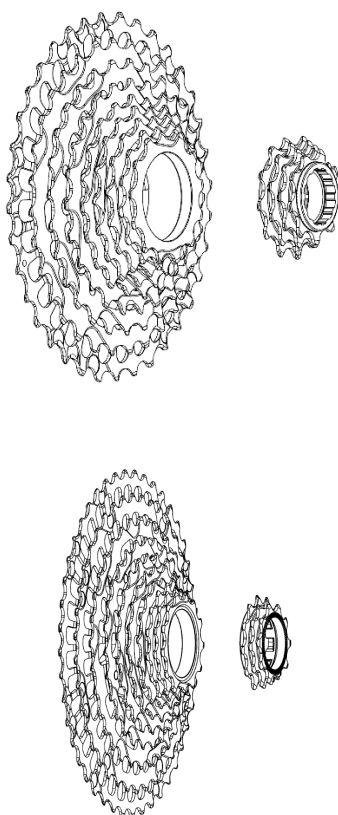
It is possible that there is a slight, sporadic creaking noise from the cassette of the Ekar groupset, particularly when pushing on the pedals. This noise does not affect the functionality or safety of the cassette.

This is more likely to happen when the rear derailleur is positioned in the sprockets next to the area where the two parts of the sprocket cassette come into contact, so for the **9-36 and 9-42** sprocket cassette in the 4th and 5th sprockets (the 1st being the smallest sprocket). In the **10-44** sprocket cassette in the 3rd and 4th sprockets
